FLOOD PLAIN INFORMATION

FLOOD HAZARD REPORT

4-7 JULY 1969 FLOOD

HURON RIVER

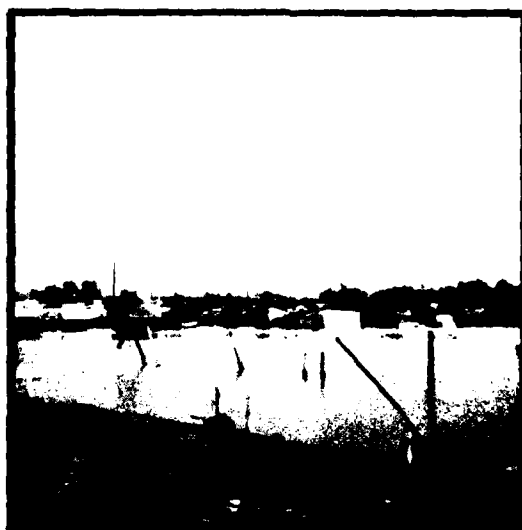
Figure 1 - Sunken boats and cars at
Holiday Harbor just upstream of Penn
Central Co. in Huron.

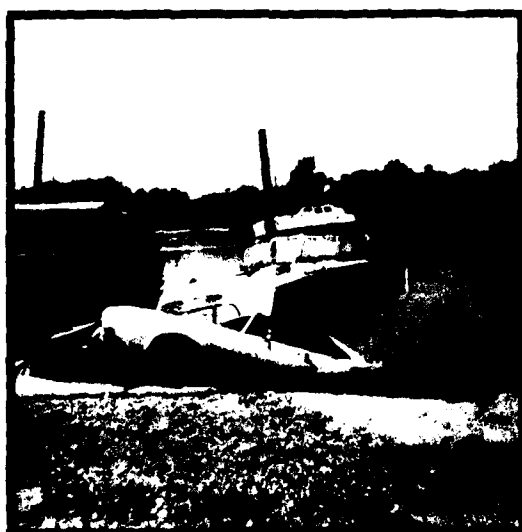
Figure 2 - Sunken boat and car at
Huron Lagoons upstream of Penn Central
Co., in Huron.

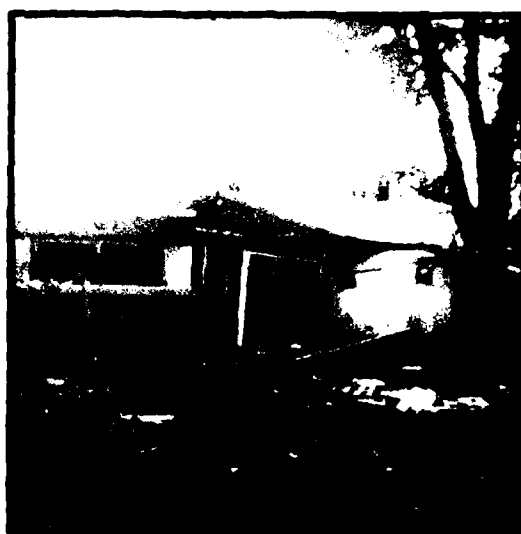
Figure 4 - Typical damage in Franklin Flats between
Milan and Huron.

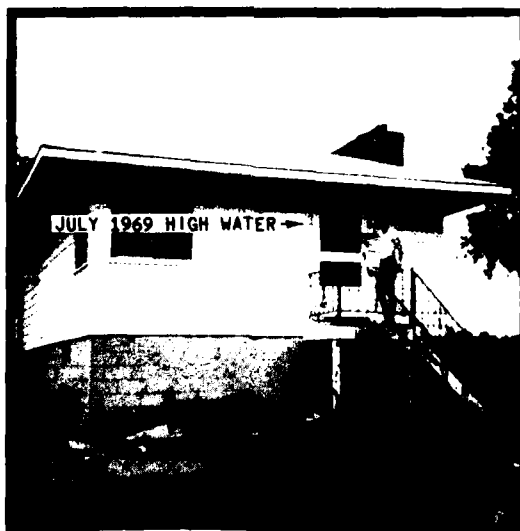
Figure 6 - Franklin Flats between Milan and Huron. Boy is pointing to July 1969 high water mark.

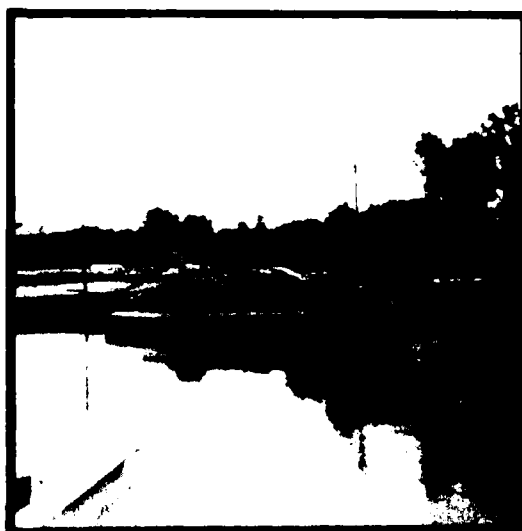
Figure 8 - Looking west along Mason Road at bridge washout. Approximately 2 miles downstream of Milan.

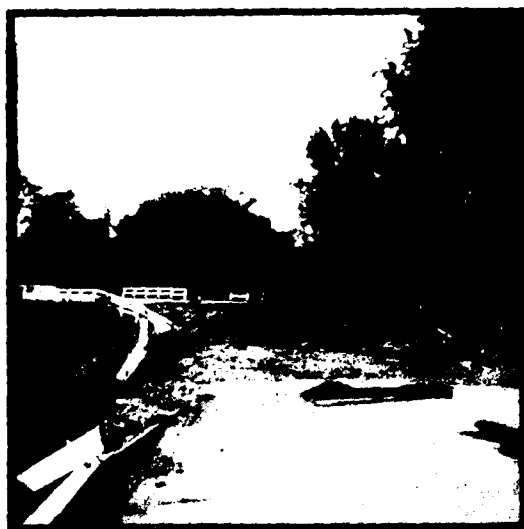
Figure 11- Looking at washed out section of Old River Road bridge in Milan. Note gage at right side of photo was covered with water.

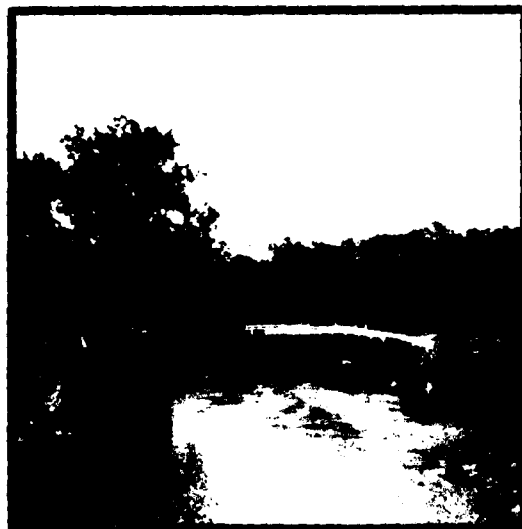
Figure 12- Looking downstream from U.S. Route 250 at Old River Road bridge in Milan, Ohio. Both approaches were completely washed away and the bridge was severely damaged and will probably not be repaired.

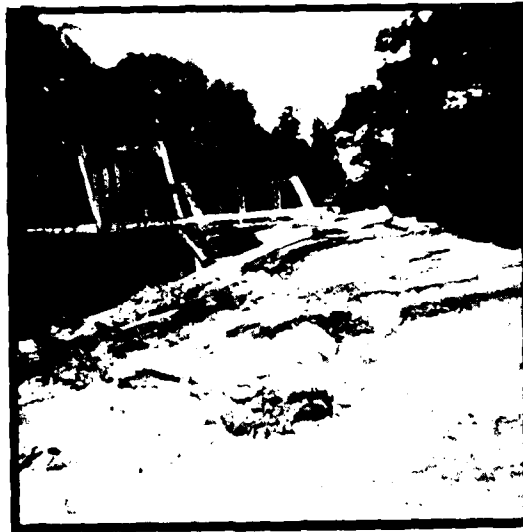
Figure 13 - Typical road washout on the West Branch at Huber Road.

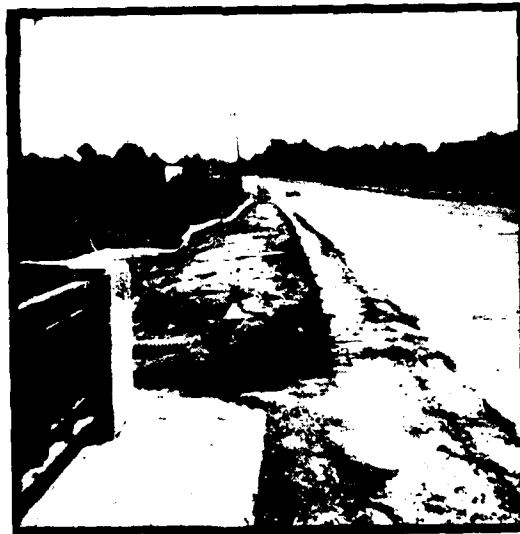
Figure 14 - Typical shoulder damage on the East Branch at U.S. Route 20.

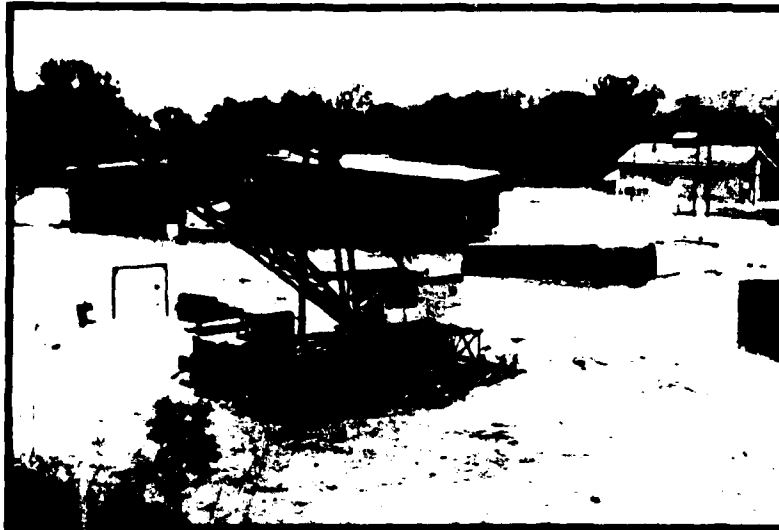
Figure 15 - Looking downstream from U. S. State Route 250
at Milan Steel and Bagley Lumber Co.

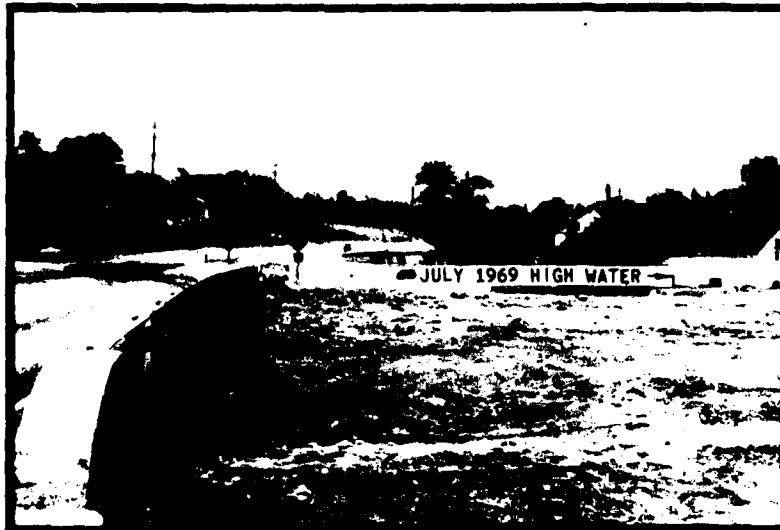
Figure 16 - Looking at upstream face of U. S. State Route 250
bridge.

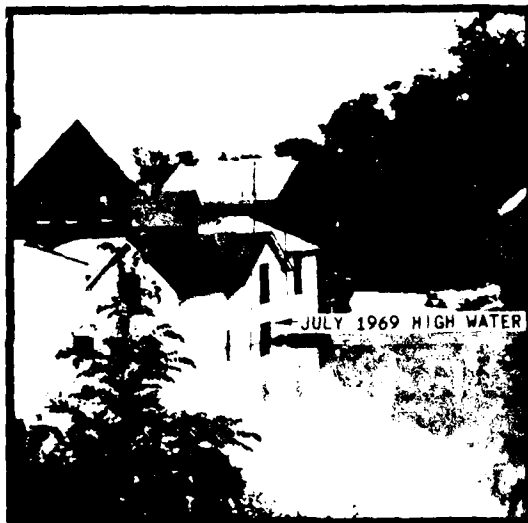
Figure 19 - Looking at rear of residence on West Water Street. Water was 7.4 feet deep on first floor at the peak of the flood.

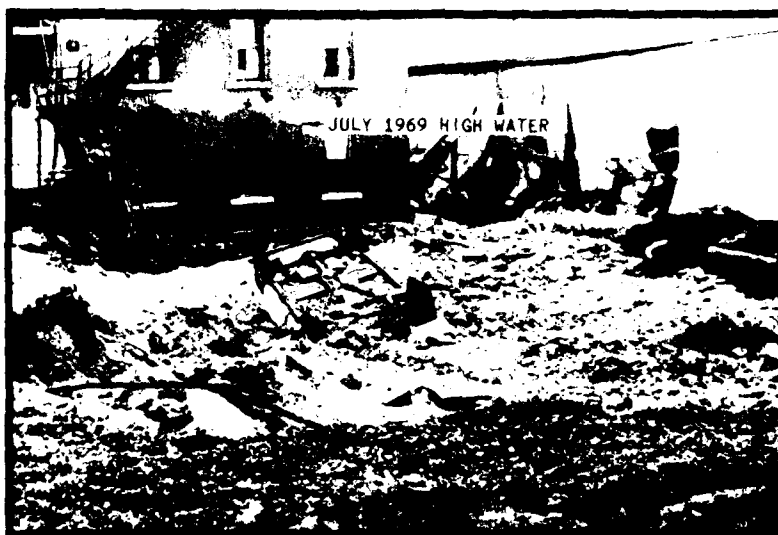
Figure 20 - Looking at rear of apartment house on West Water Street and shed or storage shed. Water was 7.9 feet above first floor of apartment building at the peak of the flood.

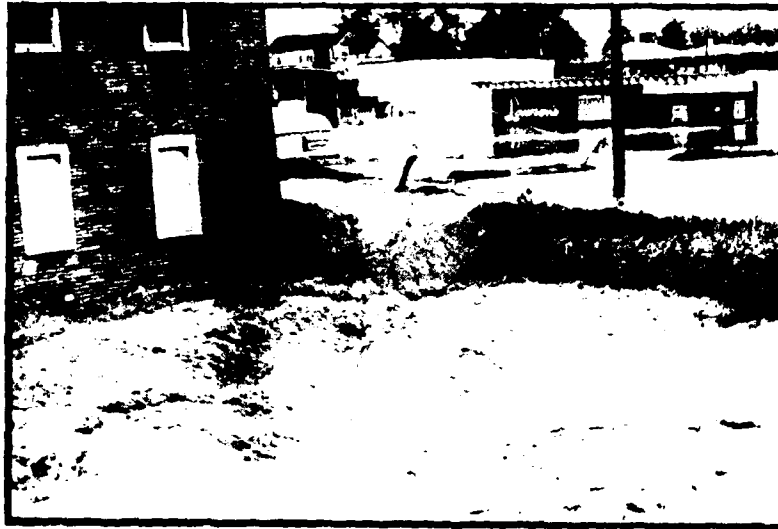
Figure 21 - Looking upstream across Benedict Avenue. Note difference in water surface elevations on building at left of photo.

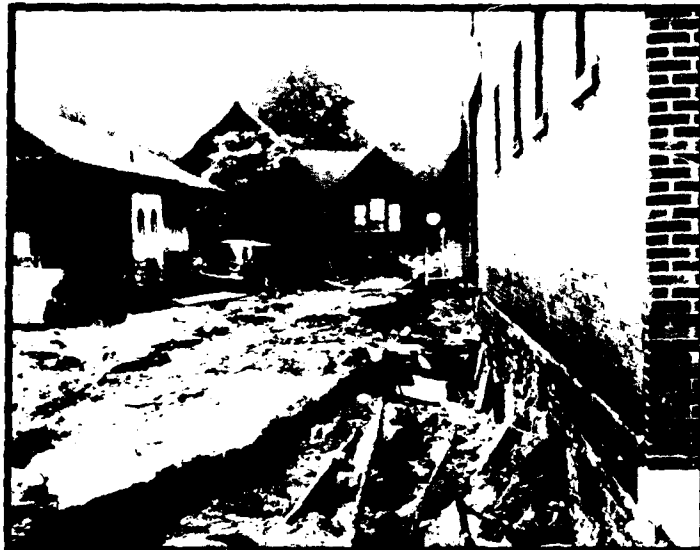
The Elm Street bridge, although cracked, remained in service. Benedict Avenue, Pleasant Street and Old State Road were washed away. Norfolk and Western Railway Company officials reported that due to extensive washouts of railroad embankments, transportation between Brewster and Norwalk was curtailed.

Figure 22 - Washout between railway depot and building on Benedict Avenue.

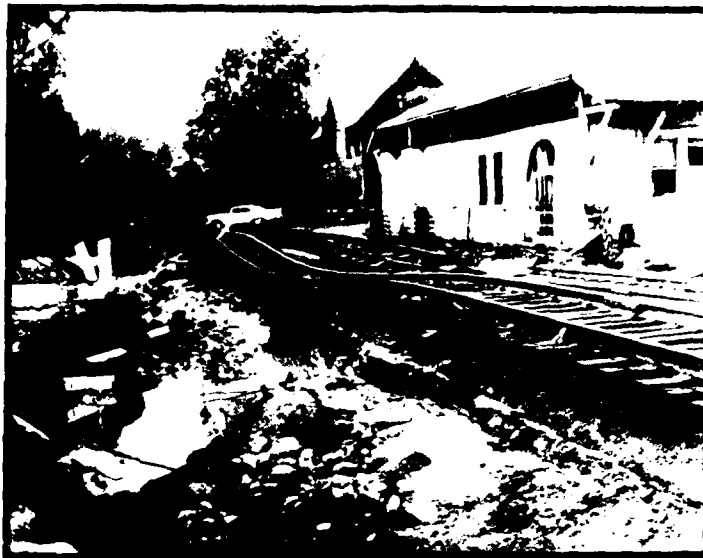
Figure 23 - Looking downstream from Benedict Avenue at railroad washout along the right bank. Photo taken 6 July 1969.

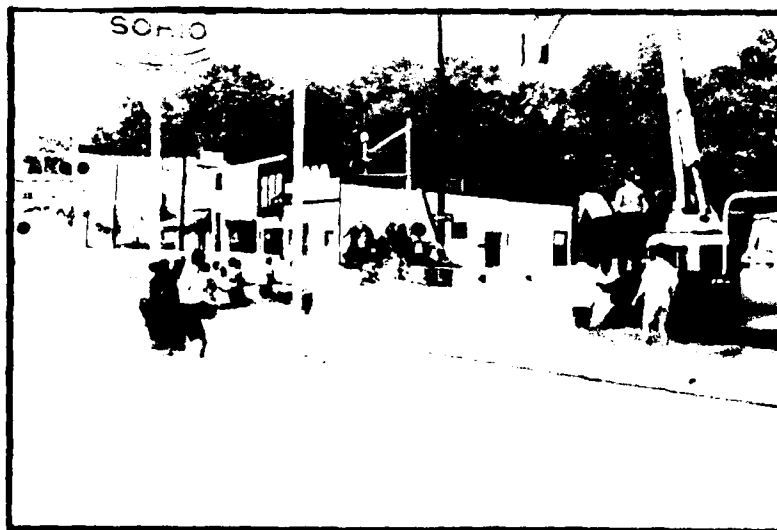
Figure 24 - Looking southerly along Benedict Avenue during rescue operations. The nose of the truck was eventually covered with water. Photo taken 5 July 1969.

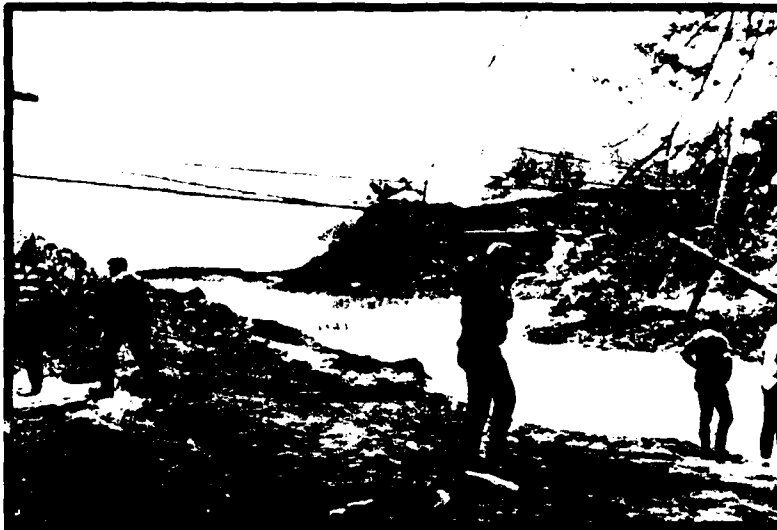
Figure 28 - Looking at break in Lower Reservoir after water escaped. Photo taken 6 July 1969.

Construction crews began repair of the Lower Reservoir in the evening of 5 July. Driving of steel sheet piling began on Sunday and was finished Tuesday. A steel sheet piling wall was driven across the break in the old masonry wall buried beneath the earth fill. The construction crews worked around the clock and minimal water and electrical service was returned by the weekend. Residents were warned by county health officials to boil all drinking water to eliminate any possibility of contamination. The county health department had found some contamination in certain areas of the city. Although water leaving the filtration plant was free of contamination, there were many breaks and leaks in the water lines from the plant to the users.
